Project No.  
**5188.002.022**

February 9, 2023

Subject: Monte Vista Villas and Campus Drive Residences  
Oakland, California

**GEOLOGIC HAZARD ABATEMENT DISTRICT  
MONITORING – FALL 2022**

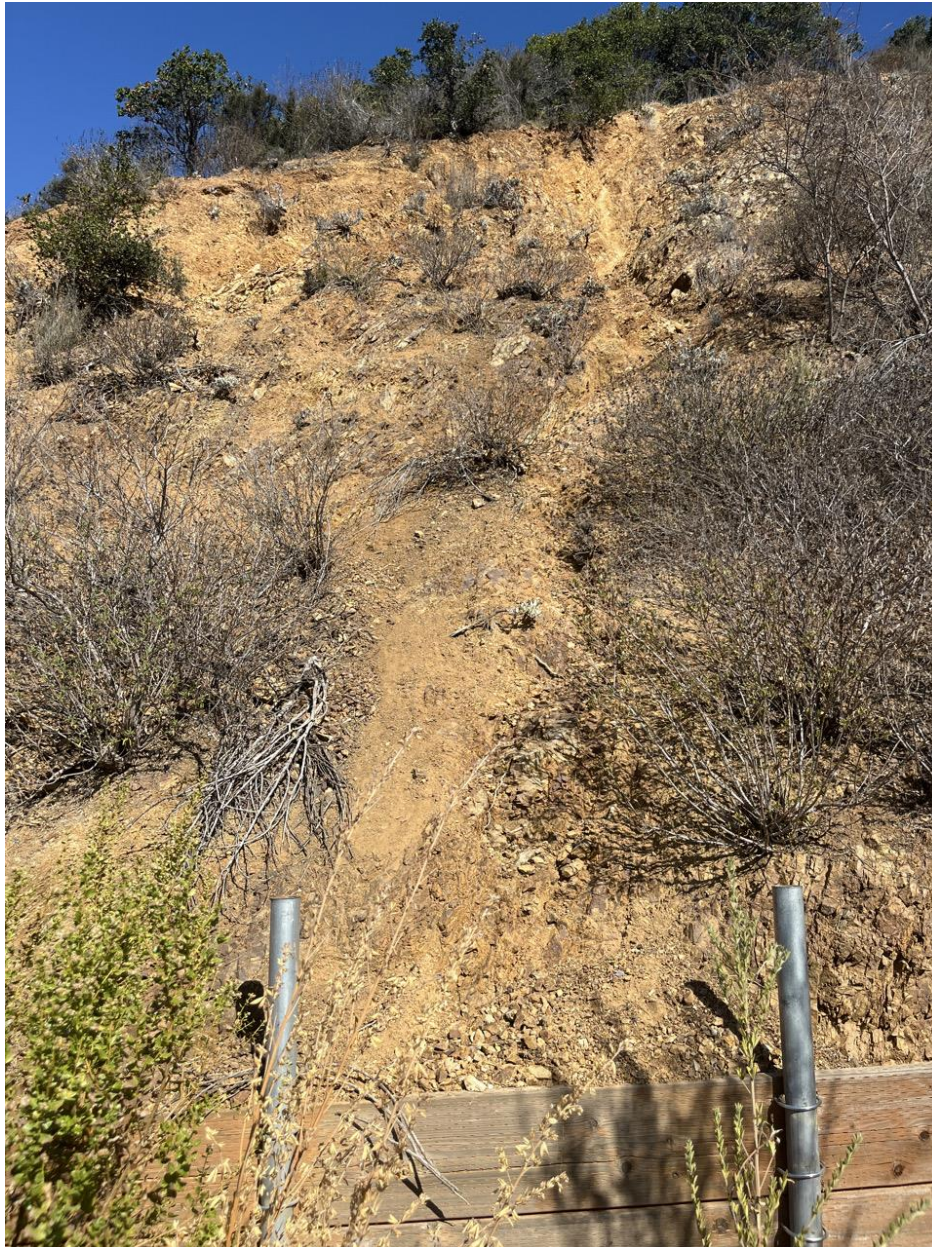
**PHOTO 1: Site Condition G**

Slopes on Parcel F and along the edge of Parcel R are in an oversteepened condition and are subject to shallow slope instability, erosion, and raveling. We previously noted in Spring 2020 that an erosion gully was located on Parcel F above the concrete-lined drainage ditch and wood-lagging debris wall (Figure 1, Site Condition G, Photo 1). Soil material from this erosion gully continued to deposit in the concrete-lined drainage ditch below these slopes. In particular, these oversteepened slopes shed debris, leaves, soil, and a fallen tree into the concrete-lined drainage ditch located below the erosion gully and also near the intersection of concrete-lined drainage ditches on Parcel F (Figure 1, Site Condition D, Photo 2). This tree was noted in the Spring 2022 Report earlier this year. If this erosion process continues and debris is allowed to accumulate within the concrete-lined drainage ditch, the capacity of the ditch will be reduced. At that time, the GHAD will consider extending the nearby existing debris wall to assist with debris capture. While the GHAD will remove the accumulated material as part of normal ditch maintenance, we expect the shedding of material from these slopes will continue.

**Erosion gully formed above drainage ditch and wood-lagging debris wall, eroded material deposited behind wall and in drainage ditch.**

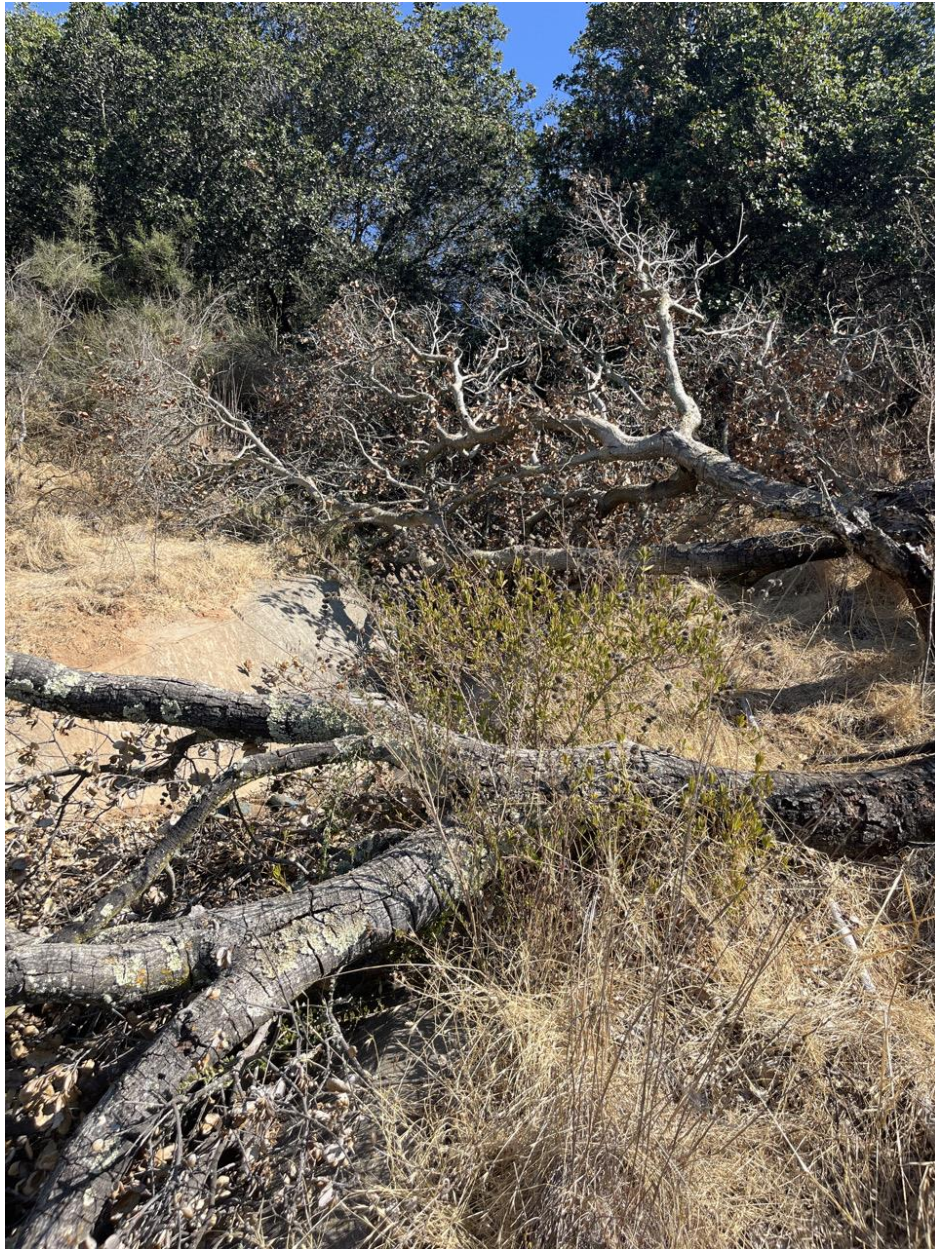
**PHOTO 2: Site Condition D**

**Fallen tree and leaves from oversteepened slope deposited in the concrete-lined drainage ditch on Parcel F**

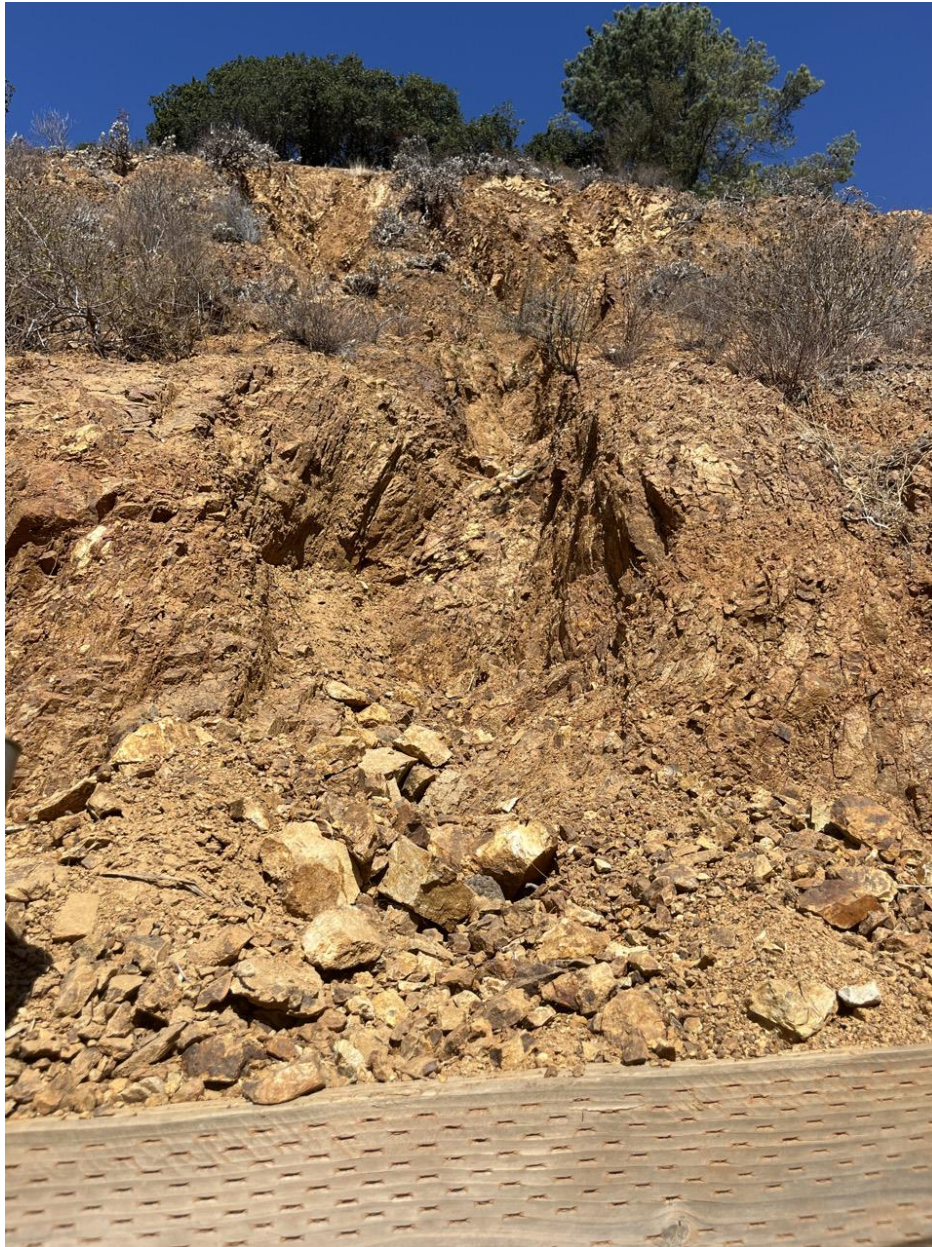
**PHOTO 3: Site Condition H**

wood-lagging debris wall. During this monitoring, we observed that the raveling from the uphill slope continued and the catchment area behind the debris wall was again full. Additionally, some of the rocks and soil overflowed from behind the debris wall into the concrete-lined drainage ditch in this area (Figure 1, Site Condition H, Photo 3). The GHAD will clear the soil material from behind the debris wall and out of the ditch to allow proper drainage during routine maintenance.

**Raveling and eroded material filled debris wall up to capacity**

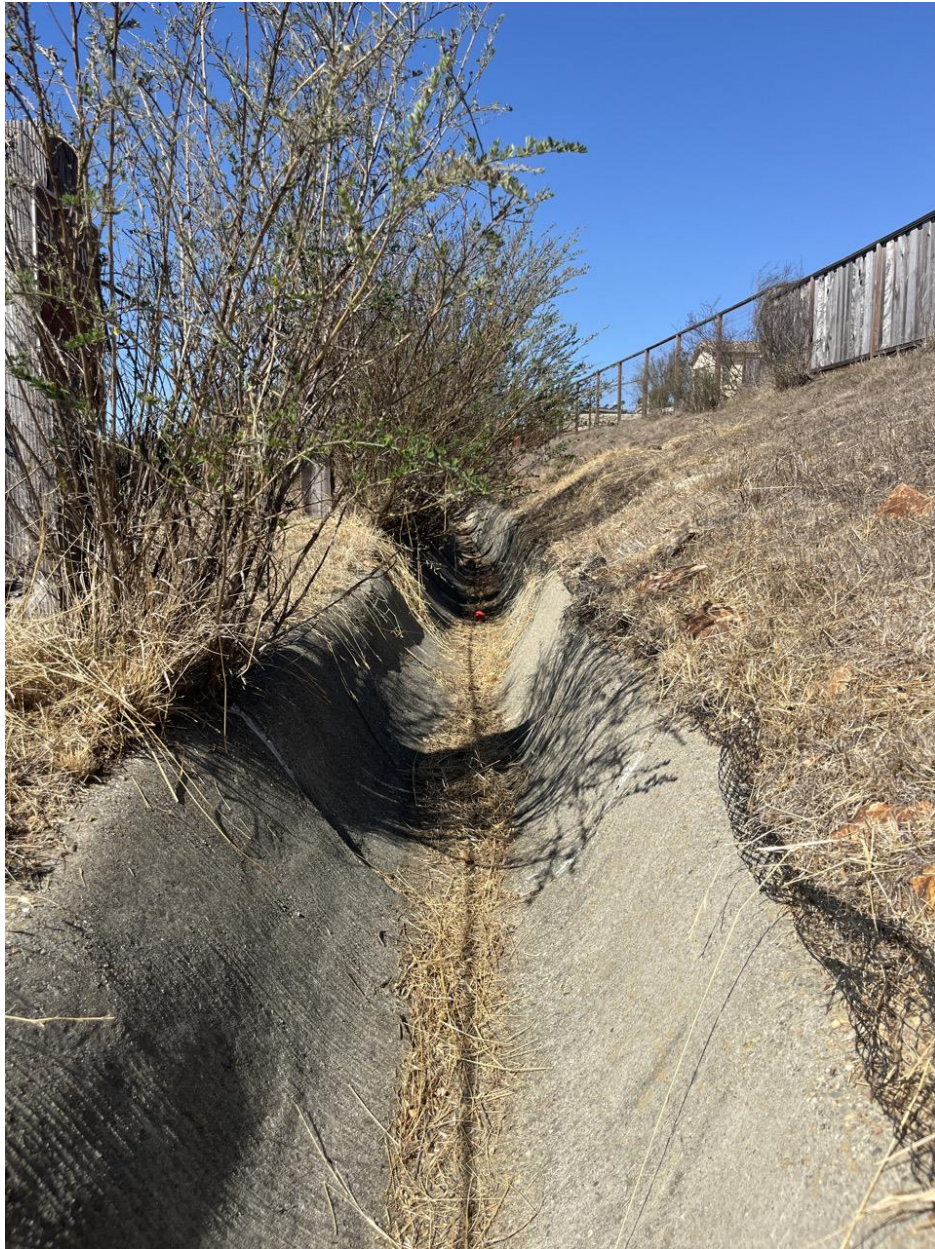
**PHOTO 4: Site Condition E**

**Overgrown vegetation within 6 inches of concrete-lined ditch.**
