Project No.
5188.002.022

June 30, 2023

Subject: Monte Vista Villas and Campus Drive Residences
Oakland, California

**GEOLOGIC HAZARD ABATEMENT DISTRICT
MONITORING – SPRING 2023**

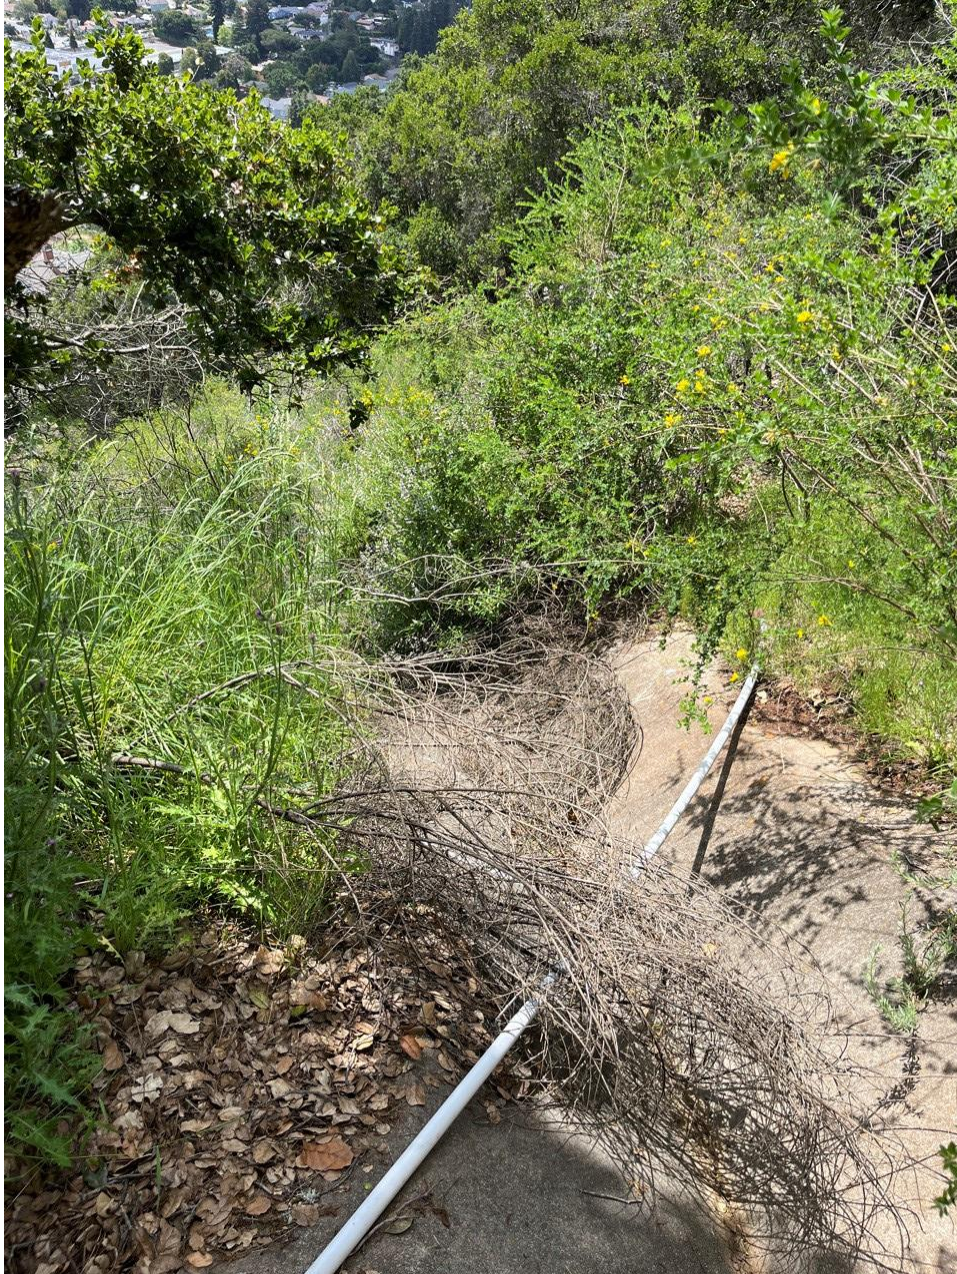
PHOTO 1: Site Condition D

Fallen tree and leaves from oversteepened slope deposited in the concrete-lined drainage ditch on Parcel F

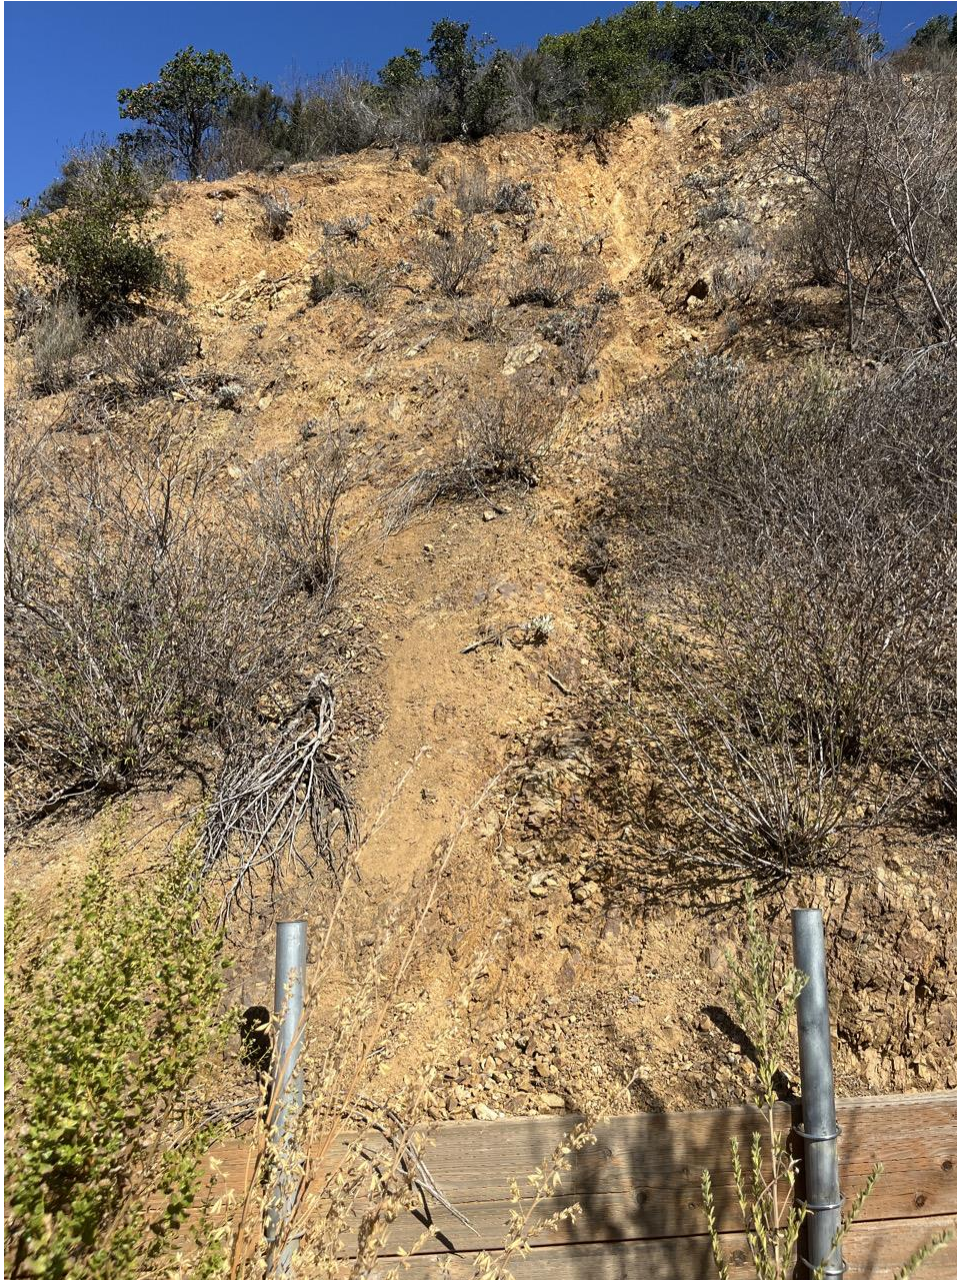
PHOTO 2: Site Condition G

Slopes on Parcel F and along the edge of Parcel R are in an oversteepened condition and are subject to shallow slope instability, erosion, and raveling. We previously noted in fall 2022 that an erosion gully was located on Parcel F above the concrete-lined drainage ditch and wood-lagging debris wall (Figure 1, Site Condition G, Photo 2). Access to this portion of the slope was prevented by fallen tree debris (Figure 1, Site Condition D, Photo 1). Additional overgrowth made access dangerous for the field tech and observations made in previous years could not be completed. It is assumed conditions are as they were fall of last year. These are that soil material from this erosion gully continues to deposit in the concrete-lined drainage ditch below these slopes. In particular, these oversteepened slopes shed debris, leaves, soil, and fallen trees into the concrete-lined drainage ditch located below the erosion gully and also near the intersection of concrete-lined drainage ditches on Parcel F. If this erosion process continues and debris is allowed to accumulate within the concrete-lined drainage ditch, the capacity of the ditch will be reduced. At that time, the GHAD will consider extending the nearby existing debris wall to assist with debris capture. While the GHAD will remove the accumulated material as part of normal ditch maintenance, we expect the shedding of material from these slopes will continue.

Erosion gully formed above drainage ditch and wood-lagging debris wall, eroded material deposited behind wall and in drainage ditch. From previous walk fall 2022 since access to this area was blocked.

The GHAD installed wood-lagging debris walls between the concrete-lined drainage ditch and the uphill oversteepened slope, where significant raveling is occurring, including on Parcel F above Blue Rock Court. We previously noted in spring 2020 that there were significant raveling and erosion from the uphill slope, and there was no longer any catchment capacity behind the wood-lagging debris wall. As previously noted, we were unable to access this portion of the Parcel. The GHAD will clear the soil material from behind the debris wall and out of the ditch to allow proper drainage during routine maintenance.

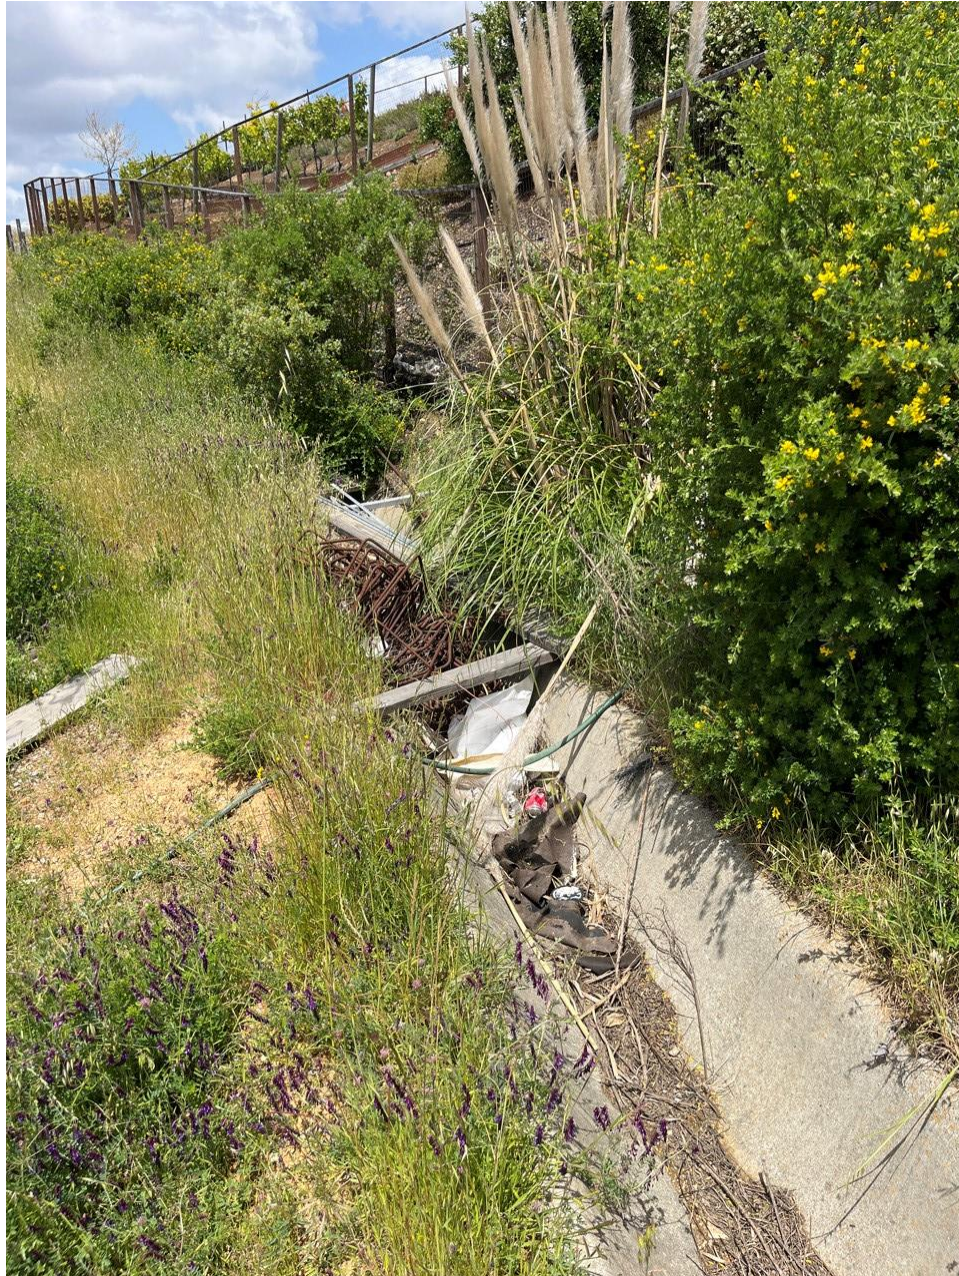
PHOTO 3: Site Condition E

Concrete, asphaltic, and earthen surface drainage ditches were viewed for evidence of sediment accumulation and distress, such as cracking or shifting. As shown in Figure 1, there are approximately 22,500 lineal feet of concrete-lined drainage ditches within the GHAD-maintained parcels. The concrete-lined drainage ditches were relatively free of vegetation and debris. Portions of the concrete-lined ditches on the slopes of Parcels F and R are in need of vegetation trimming to allow access and proper monitoring. All branches and plants should be trimmed 6 inches back from the ditch on either side to allow proper access for monitoring. We observed some minor cracking in the concrete drainage ditches that did not appear to significantly impair ditch integrity and several ditches collected debris from the raveling of the oversteepened uphill slopes. As part of the ongoing GHAD maintenance activities, debris will be removed from the drainage ditch. We also noted an excess of trash and building debris in the concrete lined ditch near the housing development in Parcel R (Figure 1, Site Condition E, Photo 4).

Trash and construction debris accumulated in concrete-lined ditch.
