Project No.  
**5188.002.024**

January 7, 2025

Subject: Monte Vista Villas and Campus Drive Residences  
Oakland, California

**GEOLOGIC HAZARD ABATEMENT DISTRICT  
MONITORING – FALL 2024**

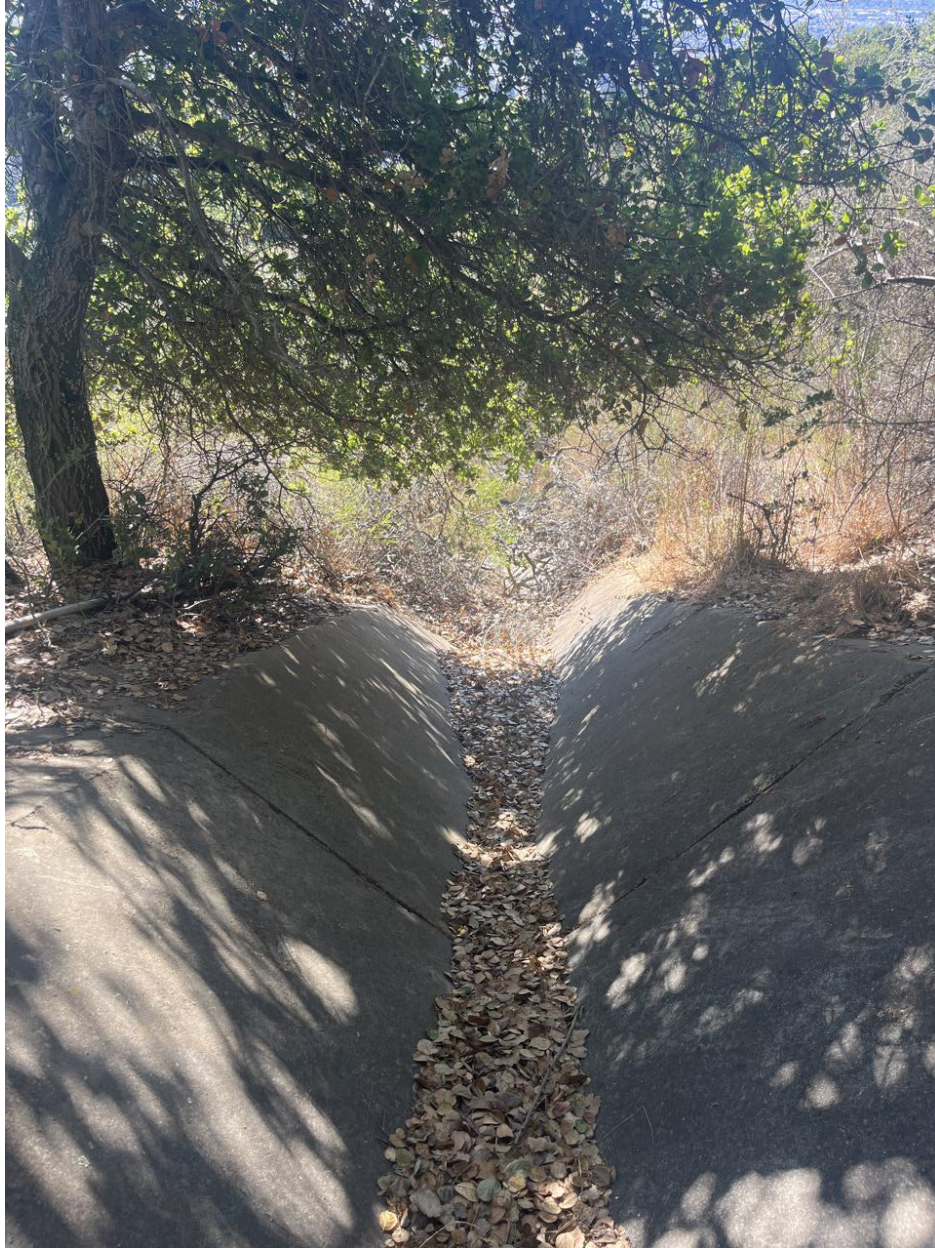
**Site Condition A – Tree debris blocking concrete-lined drainage ditch.**

Additionally, some surface drainage ditches are undergoing erosion along their downslope side. We observed some minor cracking in the concrete drainage ditches that did not appear to significantly impair ditch integrity, and several ditches collected debris from the raveling of the oversteepened uphill slopes. As part of the ongoing GHAD maintenance activities, debris will be removed from the drainage ditch.
