Project No.
5188.002.025

Subject: Monte Vista Villas and Campus Drive Residences
Oakland, California

**GEOLOGIC HAZARD ABATEMENT DISTRICT
MONITORING – FALL 2025**

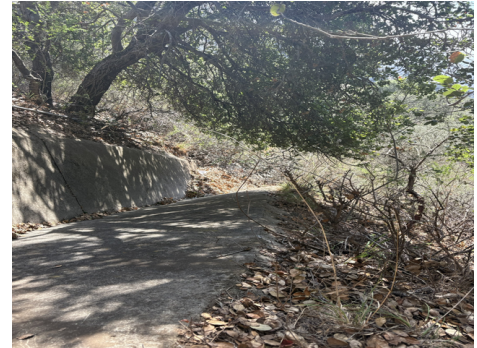
Site Condition: A
Observation Date: 11/06/2025
Description: Blockage in the concrete-lined ditch

Recommendation: Remove obstruction
