June 16, 2026

Project No.
5188.002.025

Subject: Monte Vista Villas and Campus Drive Residences
Oakland, California

**GEOLOGIC HAZARD ABATEMENT DISTRICT
MONITORING – SPRING 2026**

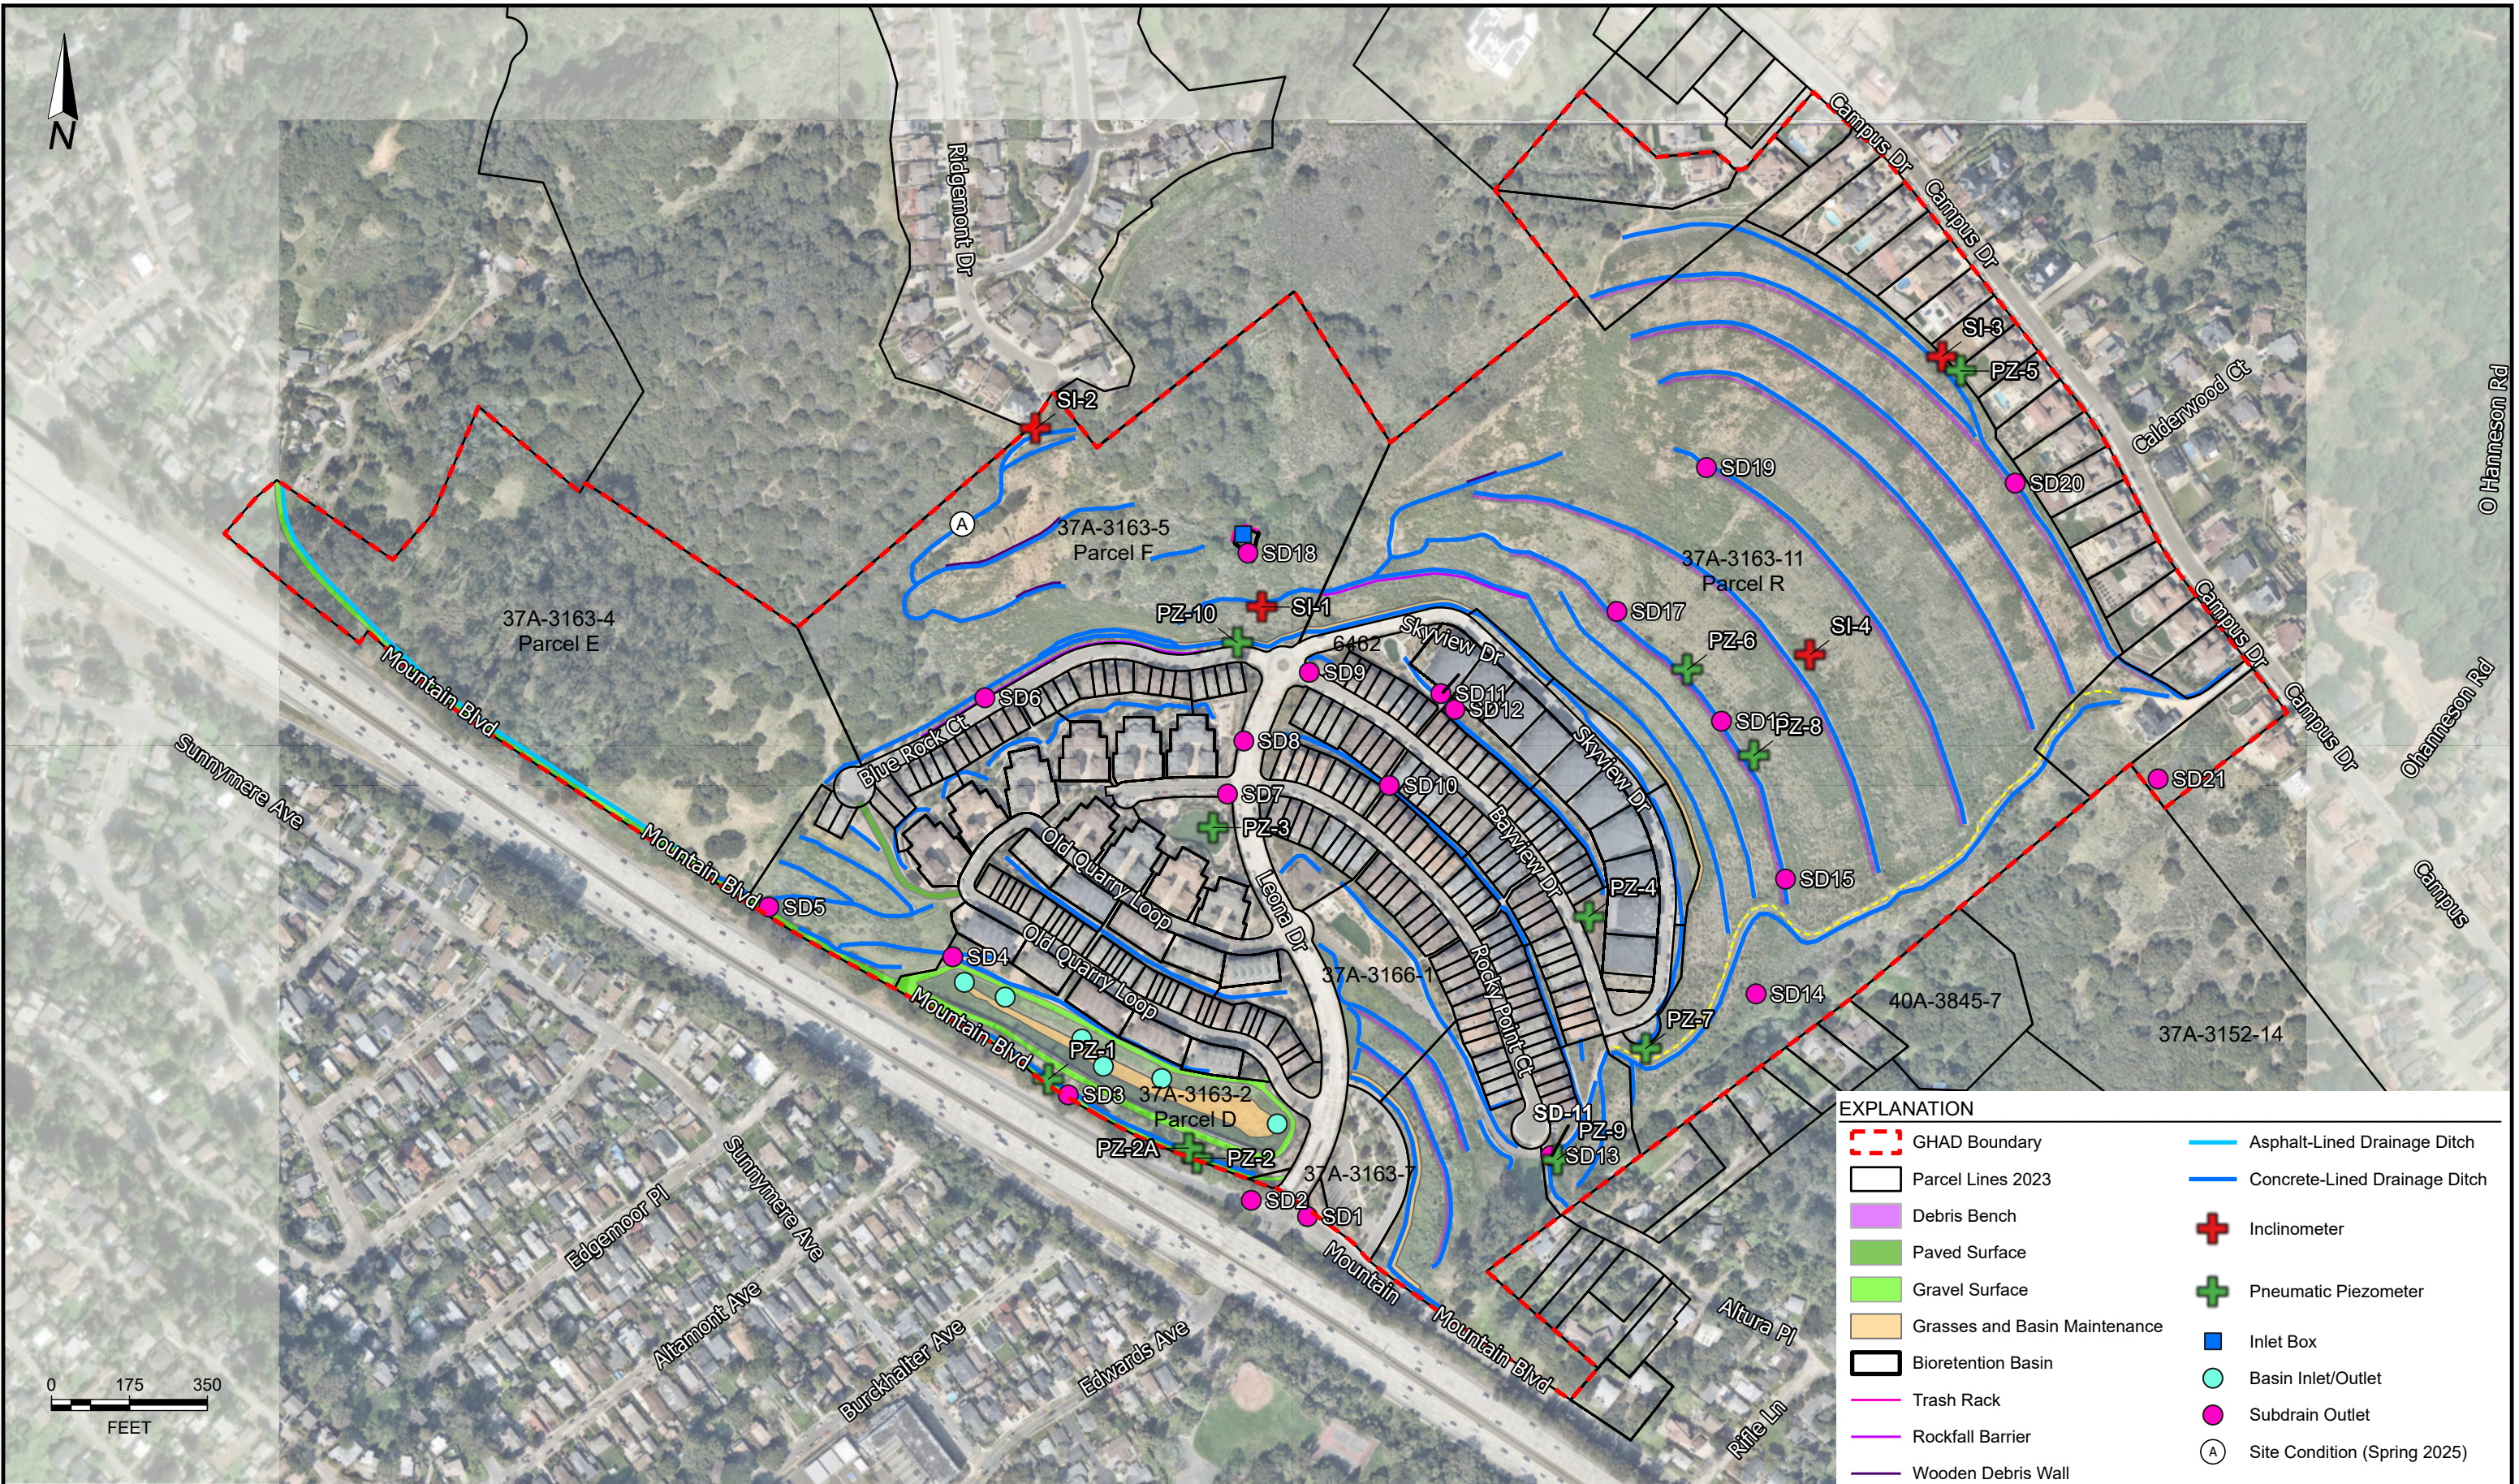
FIGURE 1

Concrete, asphaltic, and earthen surface drainage ditches were viewed for evidence of sediment accumulation and distress, such as cracking or shifting. As shown in Figure 1, there are approximately 22,500 linear feet of concrete-lined drainage ditches within the GHAD-maintained parcels. The concrete-lined drainage ditches were relatively free of debris and overgrowth. We expect that regular maintenance of the concrete-lined drainage ditches to remove debris and overgrowth will be necessary to maintain the conditions observed. This maintenance should include trimming all branches and plants 6 inches back from the ditch on either side to allow proper access for monitoring.

There are four inclinometers within the GHAD, as shown in Figure 1. The GHAD obtained readings for Inclinometers SI-1, SI-2, and SI-3. A review of the readings of Inclinometers SI-1 and SI-2 did not show displacement indicative of slope movement. Due to abnormalities in previous readings from SI-3, possibly due to deformation of the casing, the October 2022 reading will be used as a new baseline. The inclinometer data from SI-3 obtained during this monitoring event indicate a continued deflection downslope of the casing since 2024. The deflection begins at approximately 90 feet below the surface and indicates approximately 0.25 inch in the fall 2025 and another 0.25 inch since then. The shift does not alter the trend of measurements, indicating some casing deflection rather than a sharp break caused by a developing slide plane. The GHAD will continue monitoring the inclinometers periodically for indications of slope movement during scheduled monitoring events or as needed.
