Project No.  
**5188.002.024**

January 7, 2025

Subject: Monte Vista Villas and Campus Drive Residences  
Oakland, California

**GEOLOGIC HAZARD ABATEMENT DISTRICT  
MONITORING – FALL 2024**

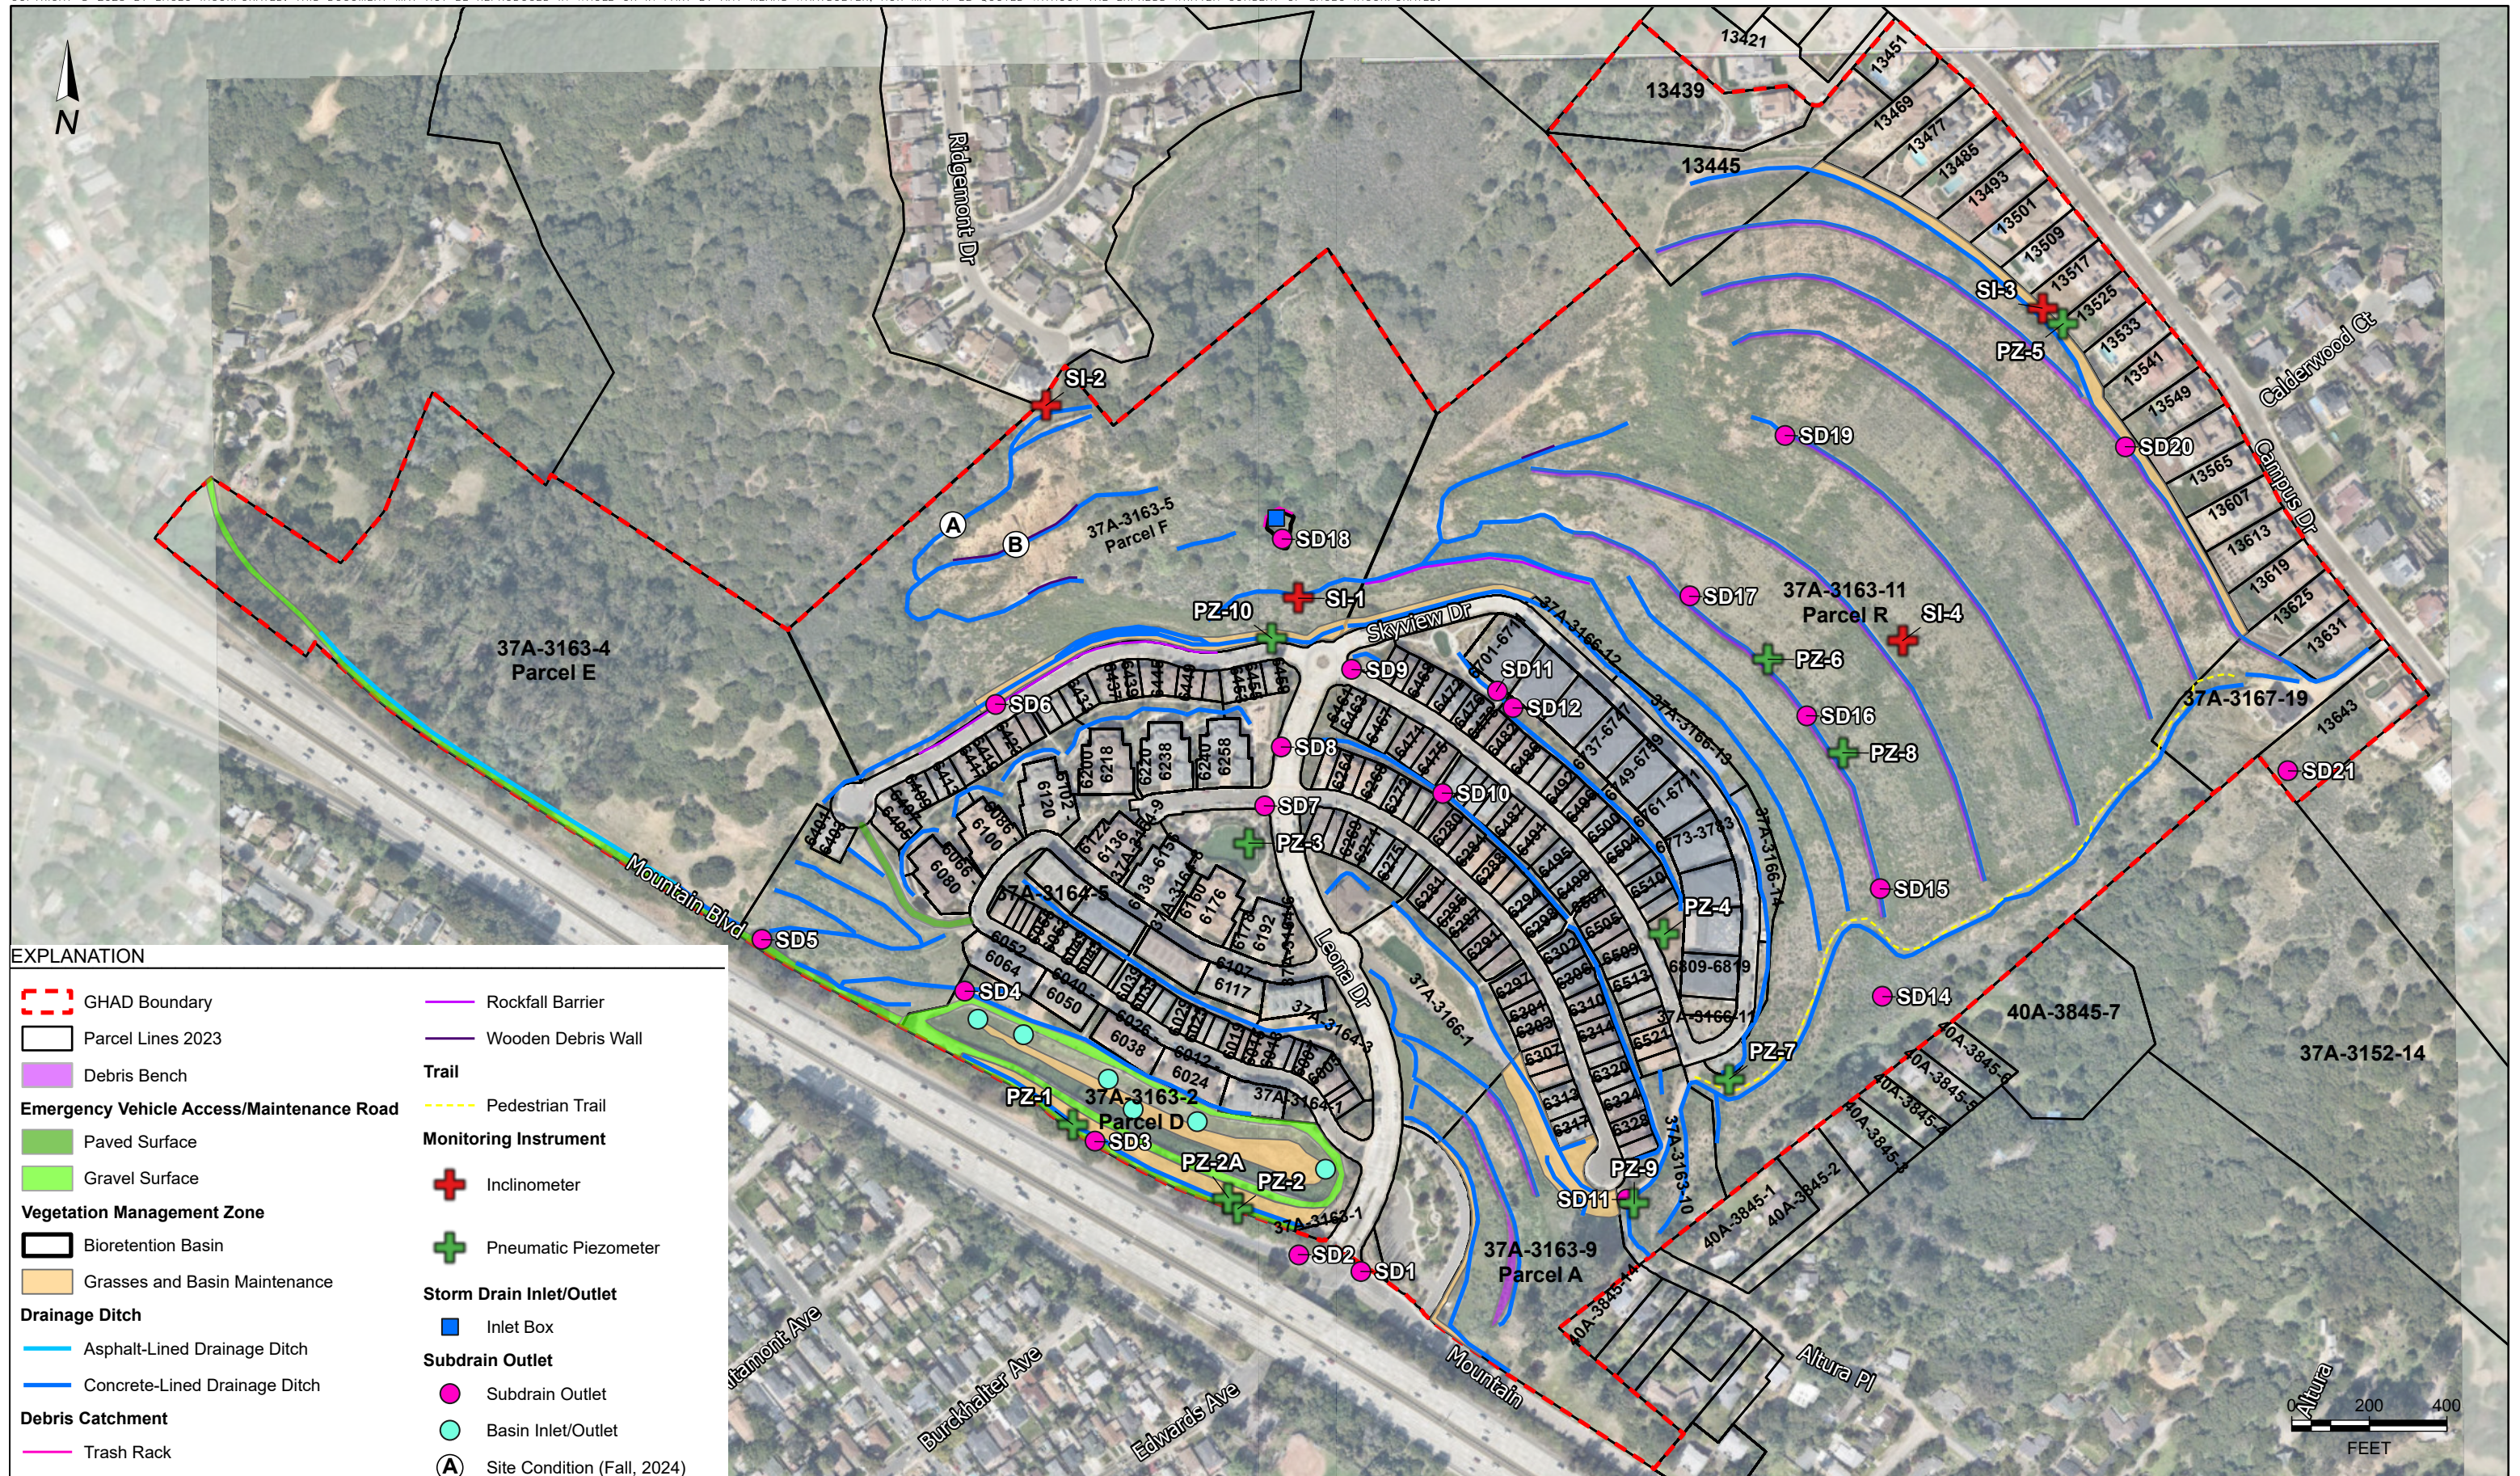
**FIGURE 1**

Concrete, asphaltic, and earthen surface drainage ditches were viewed for evidence of sediment accumulation and distress, such as cracking or shifting. As shown in Figure 1, there are approximately 22,500 linear feet of concrete-lined drainage ditches within the GHAD-maintained parcels. The concrete-lined drainage ditches were relatively free of debris and overgrowth. We expect that regular maintenance of the concrete-lined drainage ditches to remove debris and overgrowth will be necessary to maintain the conditions observed. This maintenance should include trimming all branches and plants 6 inches back from the ditch on either side to allow proper access for monitoring.

As shown in Figure 1, Subdrain Outlets SD1, SD2, SD7 through SD13, and SD20 are located within GHAD parcels but have not yet been acquired by the GHAD for monitoring and maintenance responsibilities. We collected and provided data for future maintenance requirements when the GHAD acquires the parcels.

As shown in Figure 1, Piezometers PZ-3 and PZ-4 are located within GHAD parcels where the GHAD has not yet acquired monitoring and maintenance responsibilities. When monitoring and maintenance responsibilities for the parcels containing these piezometers are acquired, data will be collected and included in future monitoring letters.

There are four inclinometers within the GHAD, as shown in Figure 1. The GHAD obtained readings for Inclinometers SI-1, SI-2, and SI-3. A review of the readings of Inclinometers SI-1 and SI-2 did not show displacement indicative of slope movement. Due to abnormalities in previous readings from SI-3, possibly due to deformation of the casing, the October 2022 reading will be used as a new baseline. The inclinometer data from SI-3 obtained during this monitoring event indicates there is no apparent downslope movement. The GHAD will continue monitoring the inclinometers periodically for indications of slope movement during scheduled monitoring events or as needed.
