**AMENDMENT 1 TO THE
PLAN OF CONTROL
FOR
LEONA QUARRY
GEOLOGIC HAZARD ABATEMENT DISTRICT
(GHAD)**

OAKLAND, CALIFORNIA

**PREPARED
BY
ENGEO INCORPORATED
PROJECT NO. 5188.1.001.02**

**AUGUST 13, 2004
LATEST REVISION FEBRUARY 23, 2005**

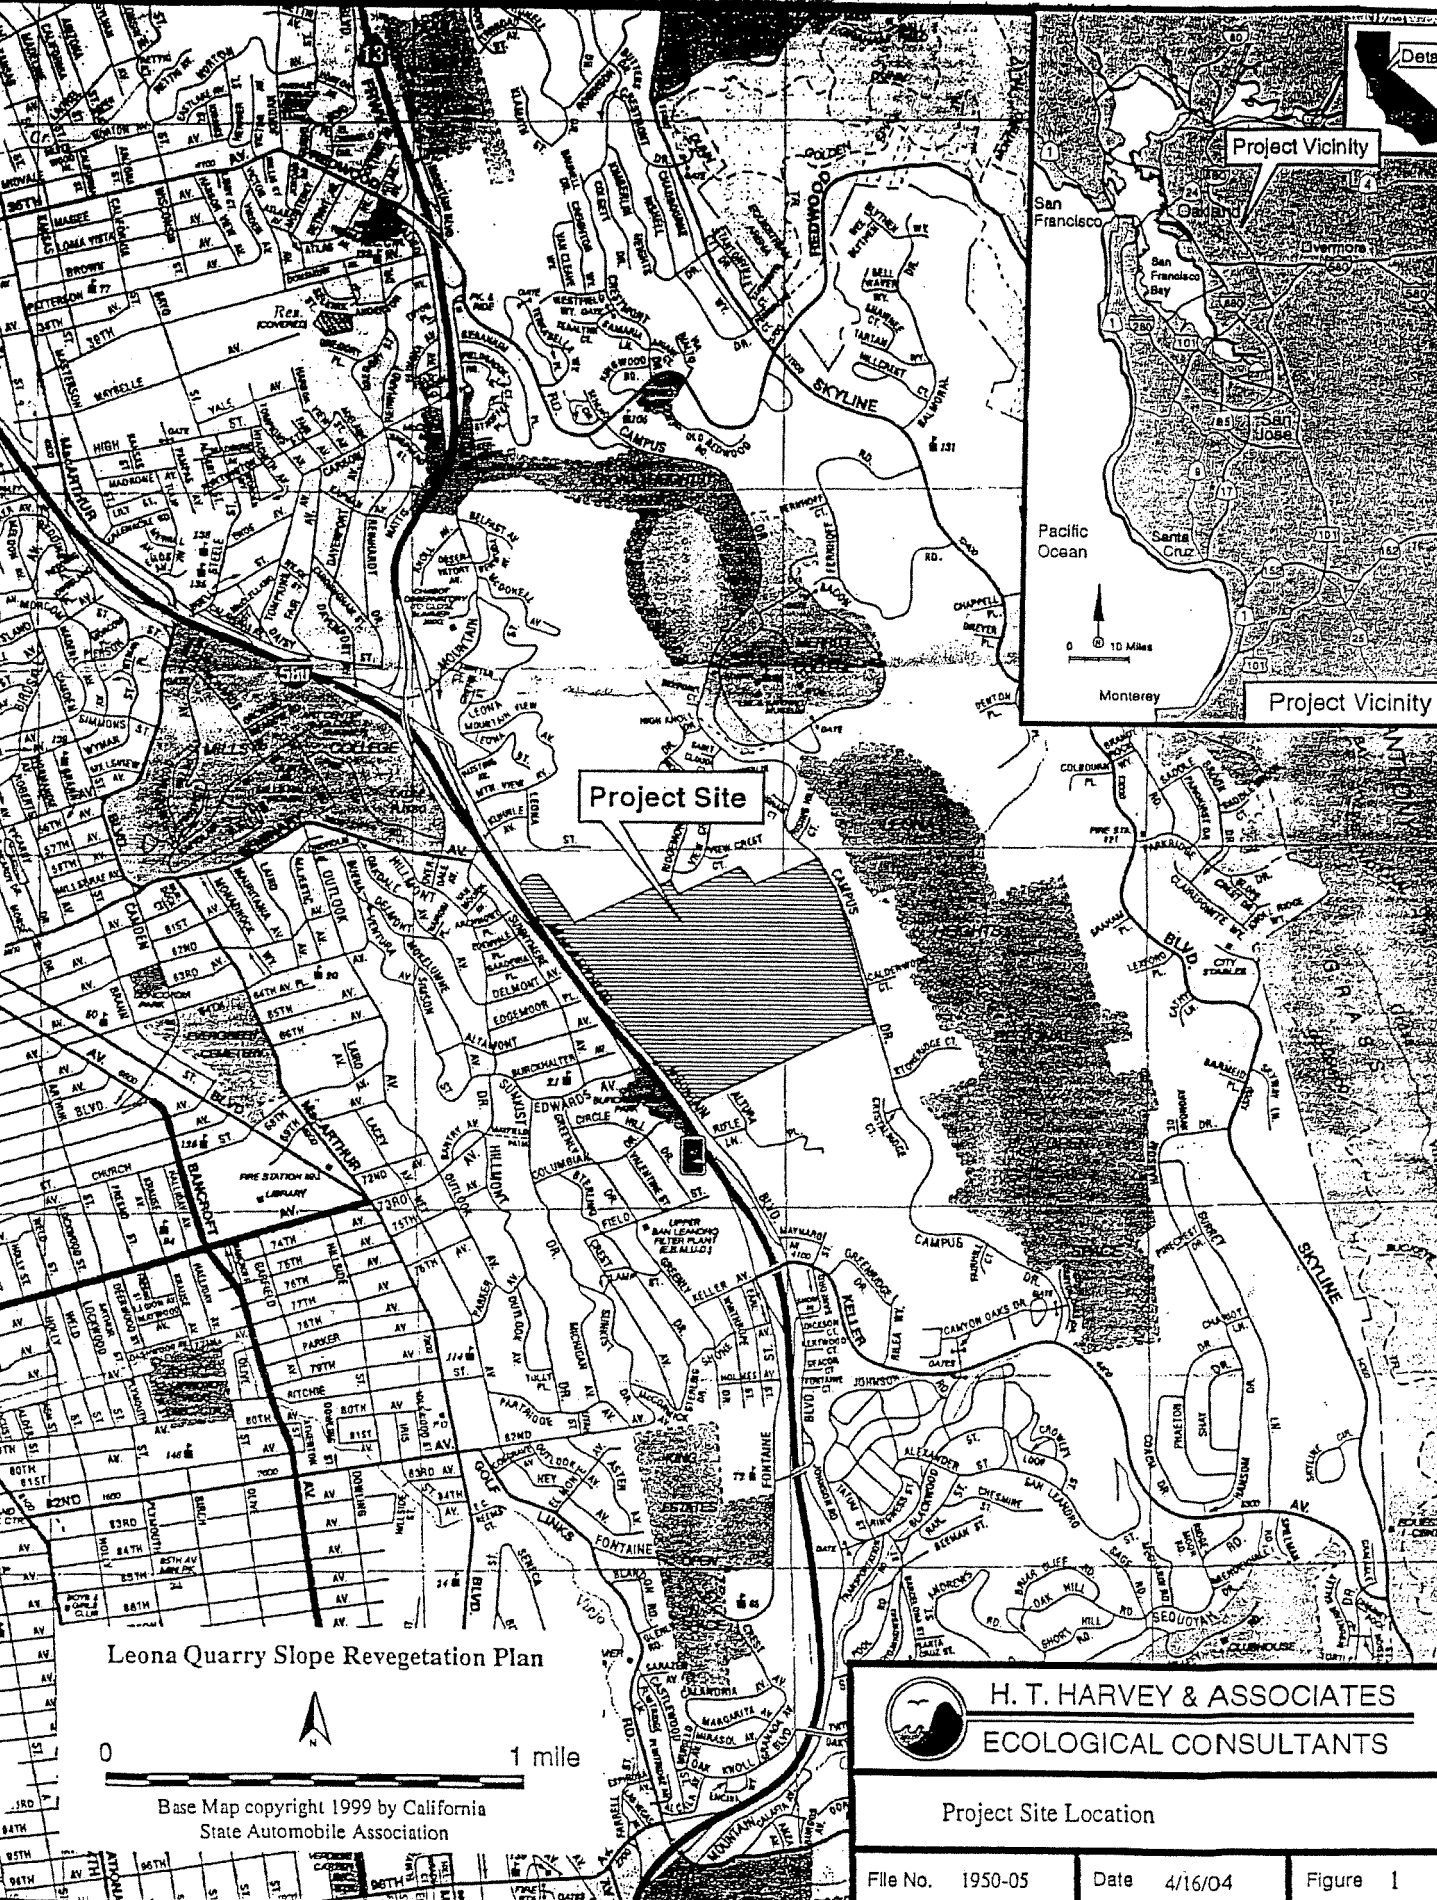
File No. 1950-05	Date 4/16/04	Figure 1
------------------	--------------	----------

Project Site Location

The Leona Quarry project site is located in southeast Oakland, Alameda County, California (Figure 1). Residential development, Highway 580 and Mountain Boulevard border the site to the south and southwest. The site extends upslope and is bordered to the northeast by Campus Drive and residential development. The Leona Heights Regional Open Space Preserve is located approximately 1.5 miles to the northeast. Relatively undisturbed sage scrub, chaparral and oak woodland vegetation border the site to the east and west. Located in the East Bay Hills, elevations at the site range from 300 feet on the southwestern portion of the quarry floor to 1067 feet along the quarry crest adjacent to Campus Drive. The Leona Quarry has been in operation as a rock quarry since the early 1900s. Throughout the life of the quarry, quarrying activities have severely altered the topography, soils and vegetation throughout the majority of the approximately 128-acre site.
